# Manhole Inspection Summary

Manhole # S41SS\_024MH

Insp Date: **2/20/07 10:05 AM**

**Location** Address: **2583 CECIL AVE**

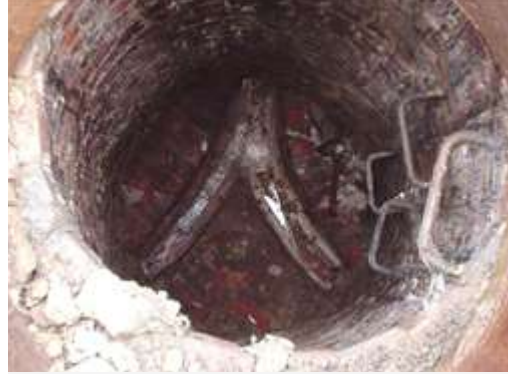
Top View

Evidence of surcharge - Bench debris.  
Channel debris.

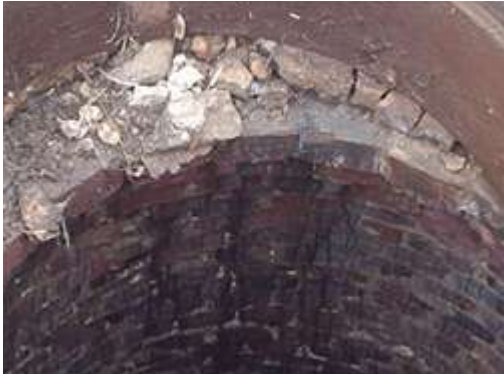
Defect

☒ **Leaks**

Condition: ☐ Sound ☐ Cracked ☐ Root Intrusion ☒ **Loose Brick** ☒ **Deteriorated**

Infiltration: ☐ None ☒ **Joint** ☐ Cracks ☐ Mortar ☐ Roots ☒ **Wall**

Infiltration: ☐ None ☐ Joint ☐ Cracks ☒ **Mortar** ☐ Roots ☒ **Wall**

Frame leaks. Frame offset. Adjustment deterioration, loose brick and infiltration. Corbel infiltration.

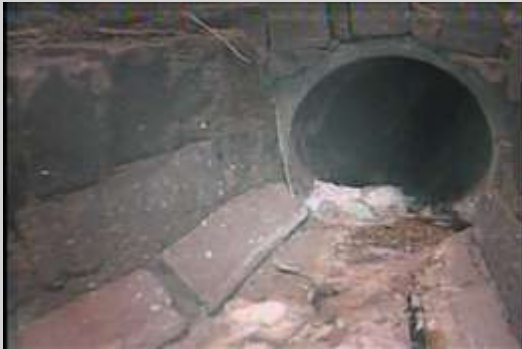
### 8 in. Circular Gravity Sewer Pipe Out @ 12 O'Clock

Deposits: ☐ None ☐ Mud ☐ Sludge ☒ **Debris** ☐ **Grease**

Infiltration: **Evidence** Pipe Seal Cond: **Cracked**

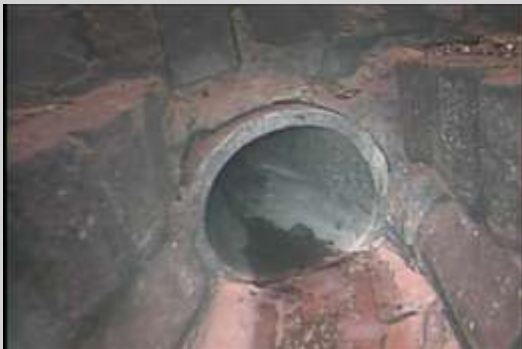
### 6 in. Circular Gravity Sewer Pipe In @ 5 O'Clock

Pipe Seal Cond: **Cracked**

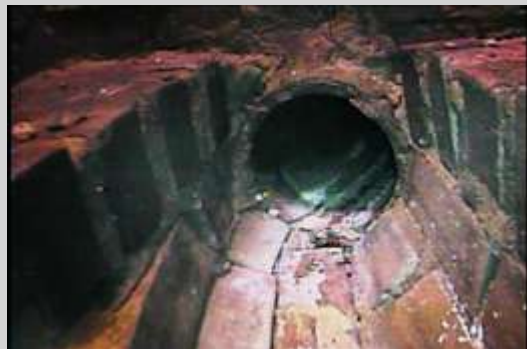
6 in. Circular Gravity Sewer

Channel deterioration.

Deposits: ☐ None ☐ Mud ☐ Sludge ☐ Debris ☒ **Grease**

Infiltration: **Evidence**

Pipe Seal Cond: **Broken**
